**EFFECT OF ENVIRONMENT ON THE FATIGUE
AND THE TENSILE PROPERTIES OF GLASS
FIBER REINFORCED VINYL ESTER AND EPOXY
THERMOSETS**

MOHAMMED SHAFEEQ

A Thesis Presented to the
DEANSHIP OF GRADUATE STUDIES

MECHANICAL ENGINEERING

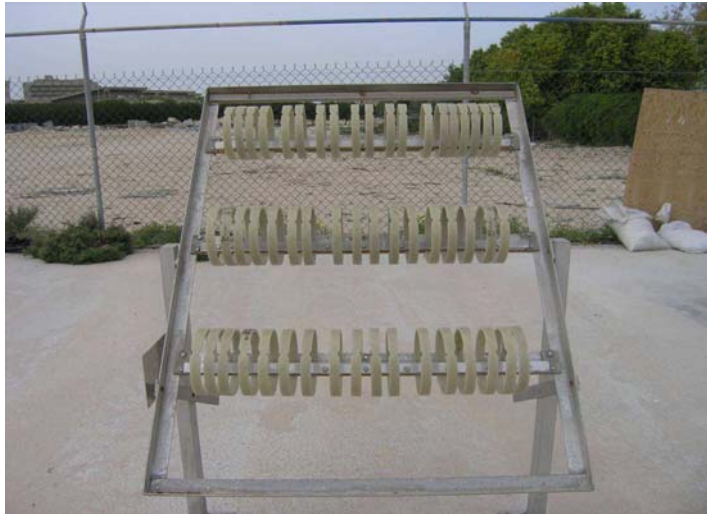
Figure 3.2: Outdoor exposure

Natural (Outdoor) environment exposure site available at KFUPM campus was selected for natural exposure. For outdoor exposure condition, specimens used were of ring type. Pipes about 160 mm length made from GFRV1 pipes is used for Crude oil exposure condition. The pipes were mounted on the six test racks as shown in the Figure 3.2. Care has been taken that the pipes should not get disturbed or damaged and were monitored regularly. Environments mimicking field conditions include prolonged outdoor exposure of test samples and pipes segments filled with crude oil.

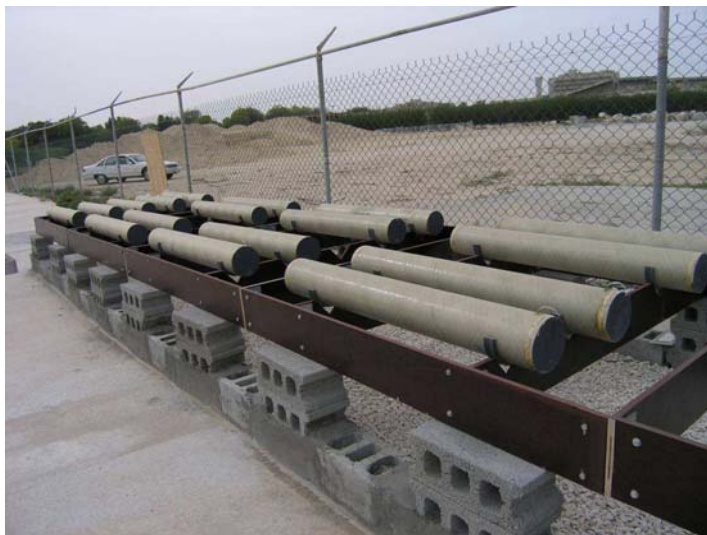
Figure 3.3: Outdoor exposure filled with Crude Oil

Pipes filled with crude oil were exposed to outdoor conditions (Figure 3.3). After exposure to various exposure periods, the ring tests specimens were obtained from emptied and cleaned pipes. Tensile tests were performed on these ring tests specimens. The results show an improvement in the tensile strength of the pipes filled with crude oil and exposed to outdoor conditions as seen in Figure 4.2. The average tensile strength increased from 253 MPa (Baseline) to 287 MPa (12 month exposure value) (Table 4.2). This improvement by about 13% in the tensile strength for the crude oil exposure was similar to the one observed in the outdoor exposure. However not much variation was observed in the average modulus values upto 12 month exposure for oil filled exposure. A slight improvement in the strain to fracture was noted with increase in the exposure time.

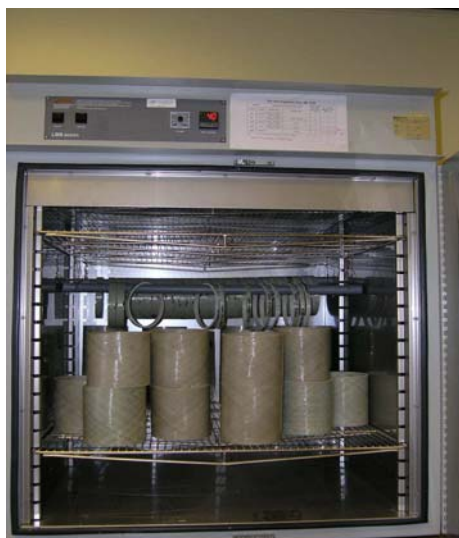
Figure 3.4: Dry heat 40⁰C exposure

The effect of dry heat on materials is important in operations using composites in a desert region, such as the Saudi Arabia. LBB Series Despatch oven has been used for dry heated exposure. This oven has an efficient forced heated air circulation to maintain a constant temperature. The oven uses an microprocessor based digital controller that maintains the actual chamber temperature to the desiring level. Ring specimens were hung using PVC pipes as shown in the Figure 3.4.

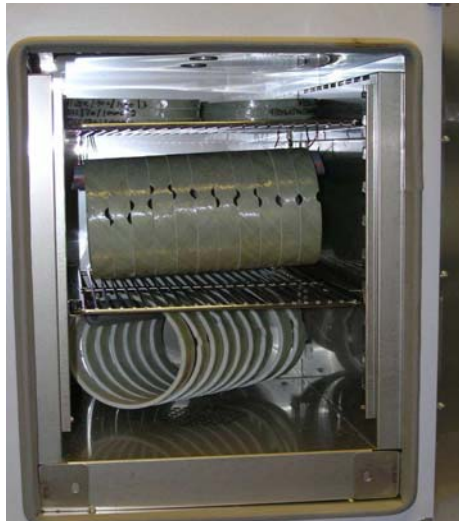
Figure 3.5: Dry heat 70⁰C exposure

Due to the harsh climatic conditions of the Gulf region, the specimens were also tested at higher temperature of 70°C. Similar to the Dry heat 40°C, the ring specimens were also kept in a separate oven at 70°C for various durations as shown in Figure 3.5.

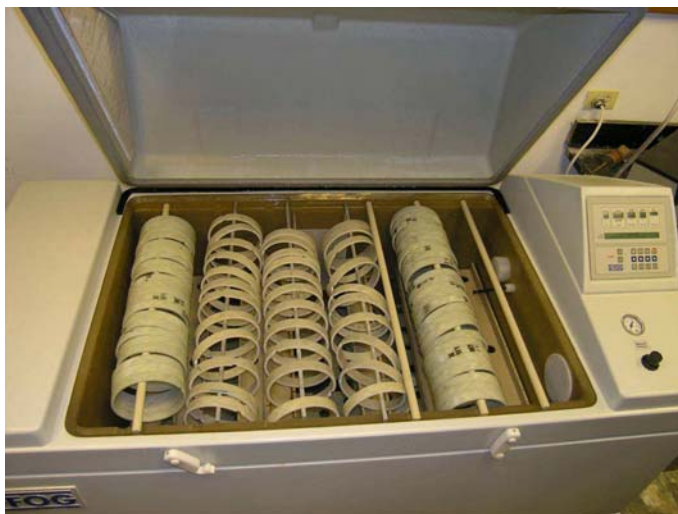
Figure 3.6: Salt spray exposure

Salt spray exposure testing was designed to provide a controlled, Salt fog environment. This test has been used extensively to provide relative corrosion or deterioration resistance data. Continuous salt spray exposures are widely specified for testing components and coatings for corrosion resistance. The apparatus used a Q-Fog CCT 600 model as shown in the Figure 3.6. The test temperature was set to 95⁰F (35⁰C) and salt fog was introduced. A 3.5% wt. salt solution was continuously atomized into the chamber. The pH was measured at room temperature after collection of the condensate and followed procedures stated in ASTM B 117 (Standard practice for operating Salt Spray apparatus).

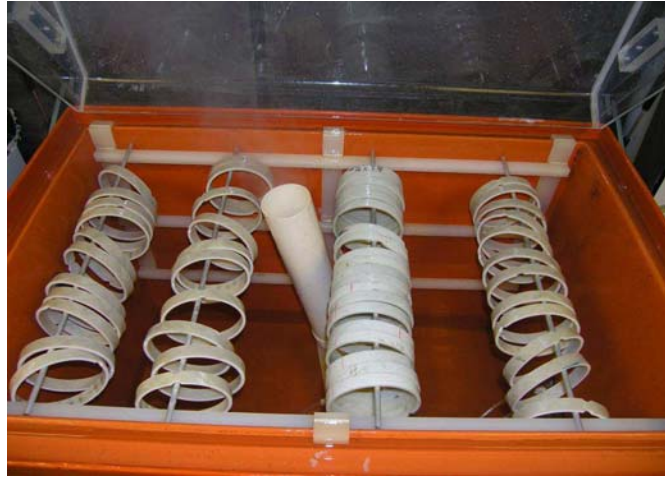
Figure 3.7: 100% Humidity exposure

Humidity also plays a very important role in the degradation of the composite pipes. During the humidity function, the chamber is maintained at 100% relative humidity by forcing hot water vapor into the chamber. Singleton Corrosion Test Cabinet model DIN FJ32H1-N-N-23 as shown in the Figure 3.7 is used for the exposure of the pipe to humidity for both the ambient and 100%. Humidity testing manual ASTM D 2246-65 (reapproved 1981) (or) D

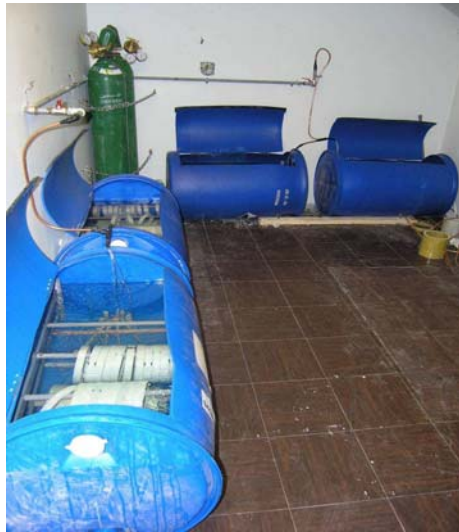
Figure 3.8: Oxygen-Salt water immersion

bers built from plastic tanks Figure 3.8. Four tanks each 50 gallon capacity were used and were half filled with sea water. Oxygen was supplied continuously in form of compressed air. Supports were designed and built to hold the composite rings in submerged salt water. Periodic inspection of the tank was done to check the level of oxygen using a oxygen meter.

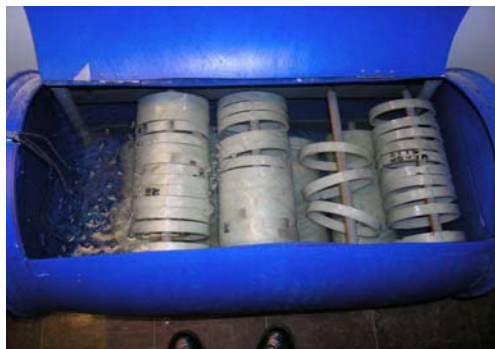
Figure 3.9: Oxygen-Salt water immersion

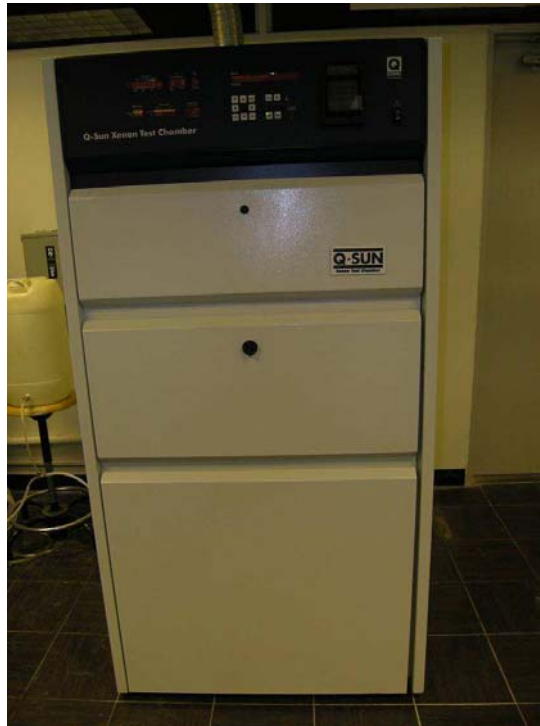
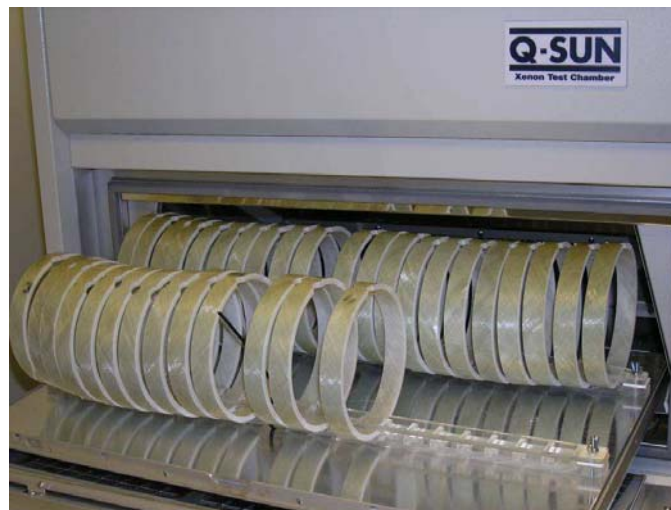
Figure 3.10: Ultra violet radiation exposure

between 290 to 400 nm, which corresponds to energies of between 415 to 300 kJ/mol. These energies are in the same range of many organic compounds. This environmental chamber will offer a temperature control between 0C and +100C, and relative humidity of 0 - 100 %. For conducting the UV tests, a Q-Sun Xenon test chamber which is a laboratory simulator for the damaging effects of weathering. It is used to test the relative humidity of materials. This chamber can produce damage that might occur over months or years of outdoor exposure. The conditions for accelerated UV exposure are as follows: UV Filter - DAYLIGHT : Q; UV sensor - 340 nm; Irradiance : 0.68 W/m²; Humidity : 10 The damage effects of sunlight are simulated using the xenon lamps. The exposure was done as per the ASTM D 4329 (Standard Practice for Operating Light and Water Apparatus Fluorescent UV and Condensation Type for Exposure of Plastics).

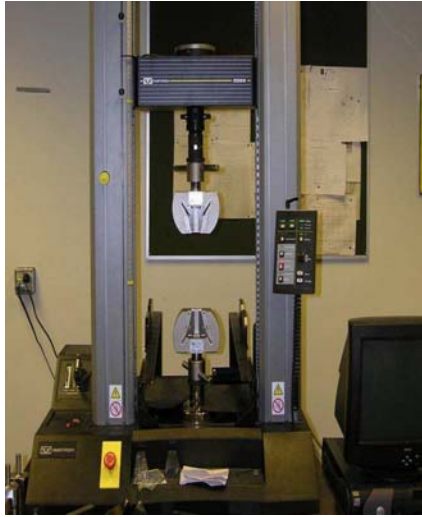
Figure 3.11: Instron 5569 machine

Tensile testing was performed on the Instron 5569 tensile testing system. Test system control, data collection and analysis are performed by Instron's Bluehill software. The machine is equipped with an environmental chamber that allows testing at non-ambient temperatures. The experimental setup is shown in the Figure 3.11

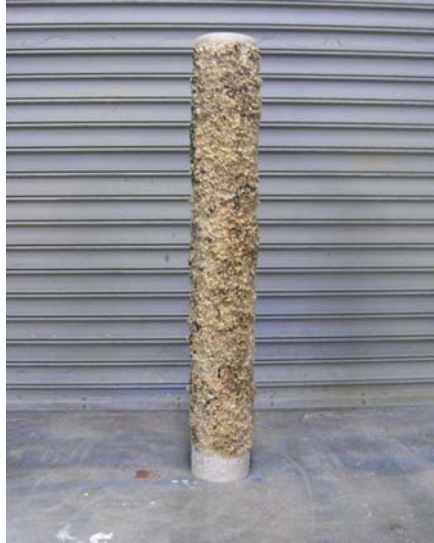
Figure 4.4: GFRV1 composite when immersed in Arabian Gulf for 12 months

The environmental durability of the pipes was evaluated by immersing the pipes in Gulf sea water for a period of 12 months. The exposed pipes were then machined to obtain ring test specimens and tensile tests were performed. Figure 4.3 shows the tensile test results for the sea water immersion condition. The results indicate an increase of about 6% in the tensile strength and about 10% decrease in the average modulus for 12 months of exposure (Table 4.3). A typical sample of the 12 month sea water immersed pipe is shown in Figure 4.4.

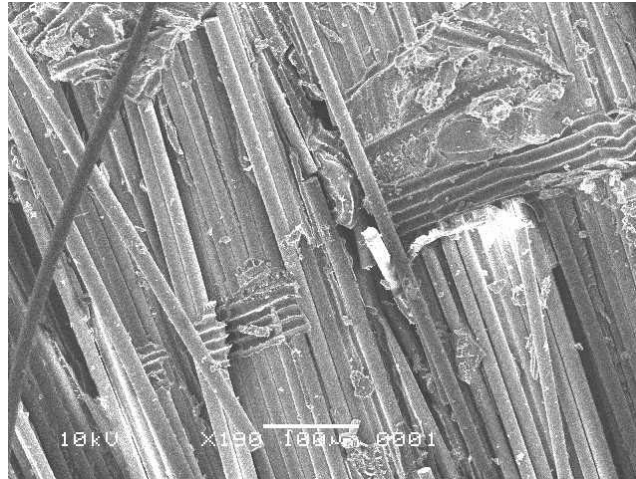
Figure 4.24: SEM microscopic image showing complete separation at interface between fiber and matrix for the as received GFRV2 pipe material

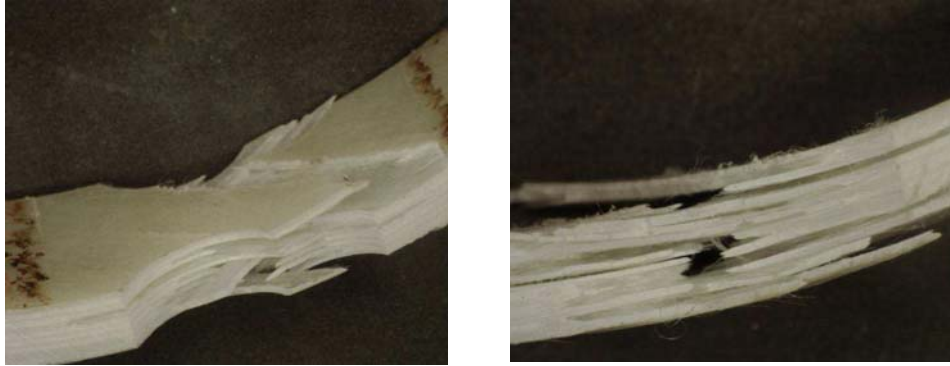
Figure 4.28: Optical micrographs showing fatigue fracture for GFRV2 pipe material exposed to Dry heat-70⁰C condition for 1000 hours
